Home Inspection Report

12 Grimmauld Street, Londonville, IL 60109

Saturday January 1, 2022

22-0115.1

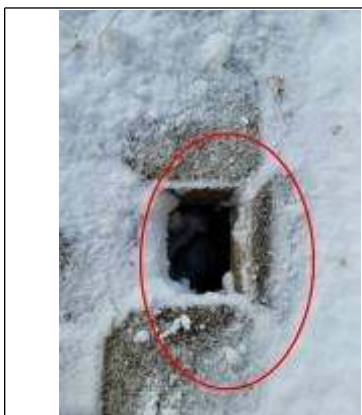
Service walk entrance at the South entrance to the garage is missing a cover over the stormwater drain. Potential safety hazard. Recommend installing drain cover for safe use of service walk

Missing drain cover of service walk at South entrance to garage

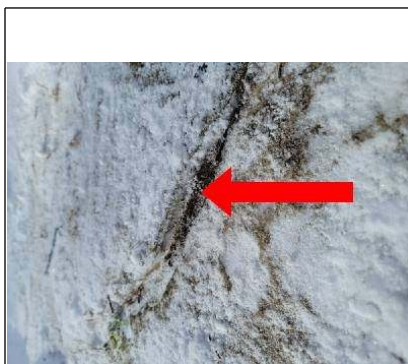
Concrete service walk on the south side of the home is cracked and settled creating trip hazards. Recommend repair of settled service walk materials of the property to provide a smooth surface for safe pedestrian use

Cracked and settled concrete service walk south side of home

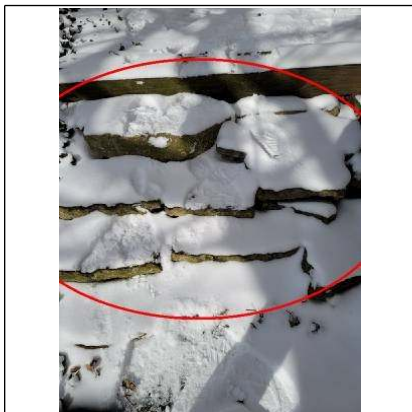
Steps at the elevation change on the west side of the property are improperly constructed. Recommend reconfigure steps to provide even riser Heights and tread depths for safe use

Improper configuration of steps at elevation change at the Southwest area of the grounds

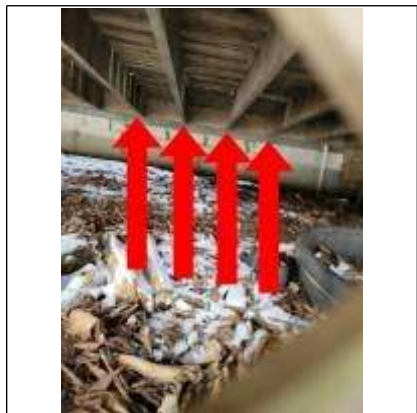
Joists of the deck are not installed with proper joist hangers. Recommend installing joist hangers for secure attachment of the joists to the ledger board and to prevent separation from the home

Missing joist hangers of decking south side of home

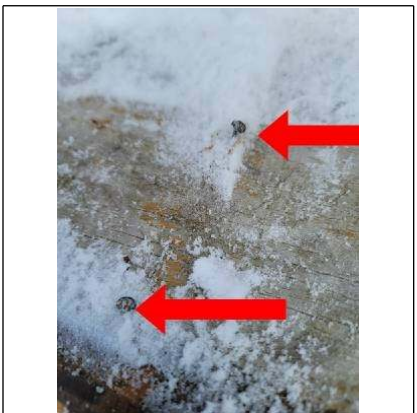
Protruding fasteners found on the steps of the deck. Recommend removal or seating fasteners to prevent injury

Protruding fasteners of tread at steps to decking

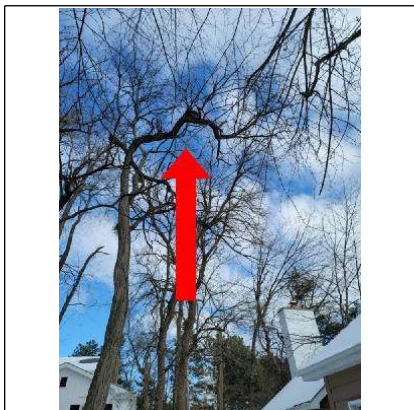
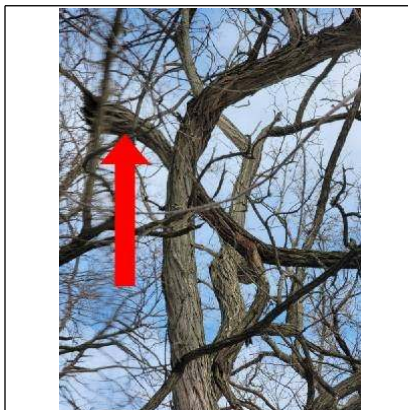
Tree on the north side of the home has broken and horizontal limbs. Recommend qualified arborist contractor remove as needed to prevent injury and damage from falling limbs

Horizontal tree limb over north side of home

Broken and suspended tree limb north side of property

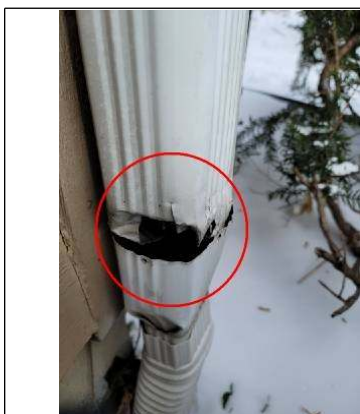
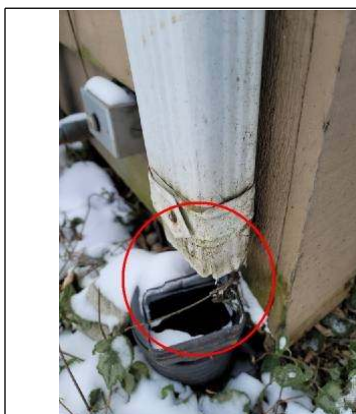
Downspouts on the east side of the home are detached from extensions. Recommend repair of downspout to extension attachments for proper distribution of roof water away from the foundation of the home

Damaged and detached downspout connection Southeast corner of home

Detached downspout from extension northeast corner

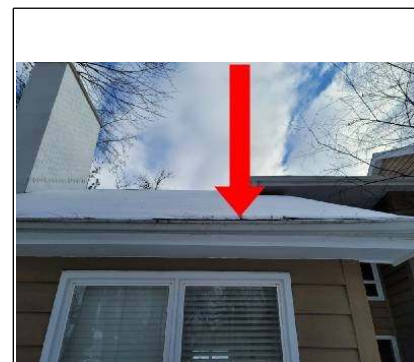
Gutter of the first floor Eave on the north side of the roof is detached and missing straps. Recommend repair of gutter installation for proper distribution of roof water to the downspout

Damaged and detached gutter first floor North exposure

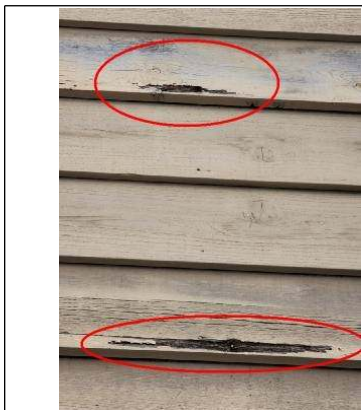
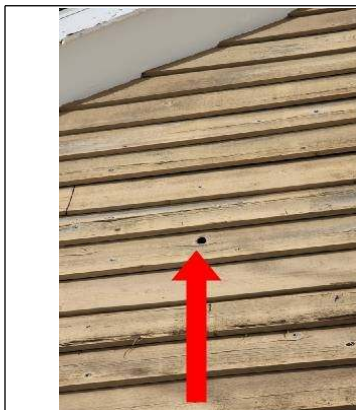
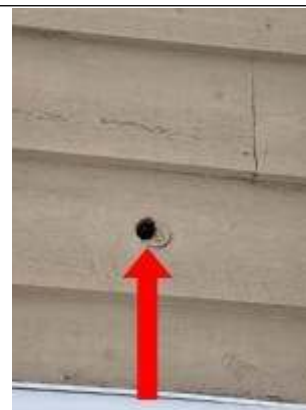
Exterior wood siding materials have areas of damage. Recommend repair or replacement of damaged siding materials

Damaged exterior wood siding South West exposure

Hole in exterior wood siding West exposure

Hole in exterior wood siding east side of home

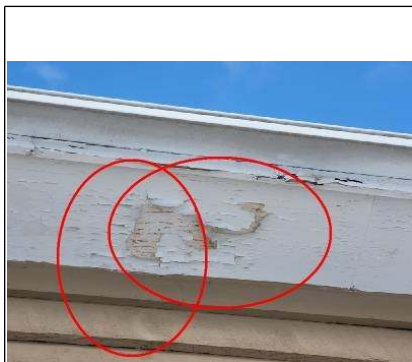
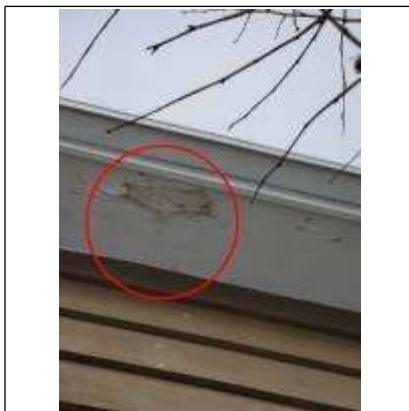
Exterior wood materials of the soffit and fascia of the roof eaves have several areas of peeling paint. Recommend removal of all deteriorated and peeling paint and reseal wood materials to prevent wood rot

Peeling paint of wood soffit material south side of roof

Peeling paint of wood soffit materials south side of roof

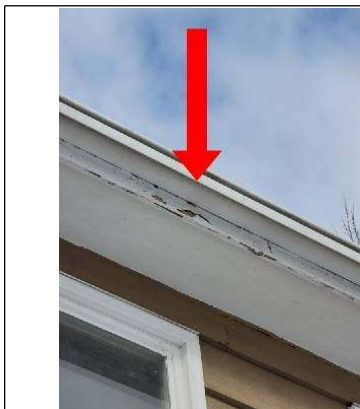
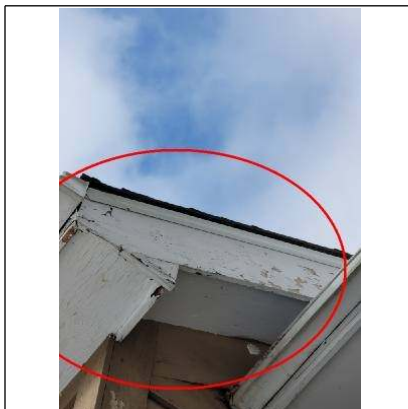
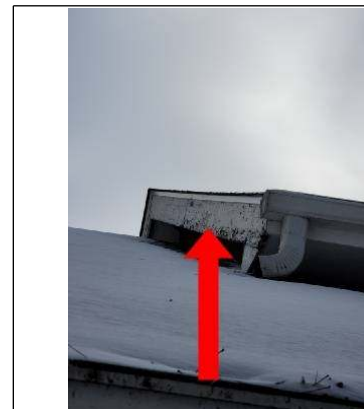
Deteriorated and peeling paint of wood fascia materials south side of roof

Deteriorated and peeling paint of wood fascia and soffit materials

Peeling paint of exterior wood fascia materials yeast exposure over living room

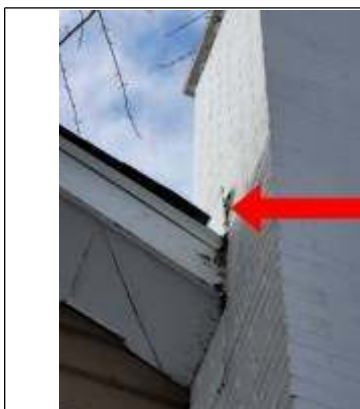
Exterior aluminum flashing of the East chimney is detached. Recommend qualified sighting contractors secure all loose flashing materials to prevent water intrusion into the sheathing materials of the attic and home

Detached aluminum flashing of chimney Chase east side of home

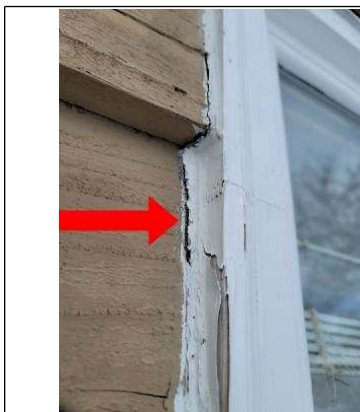
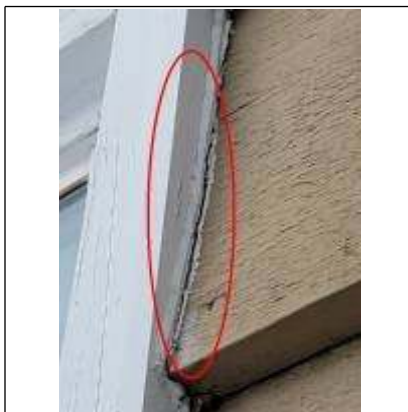
Exterior sealant of the window and door penetrations of the homes beginning to dry and crack and separate from the siding materials. Recommend replacement of exterior sealant around windows and doors to prevent water intrusion into the framing materials of the home

Dried and cracked exterior caulking of window penetration south side of home

Tried and detached sealant of exterior window penetration south side of home

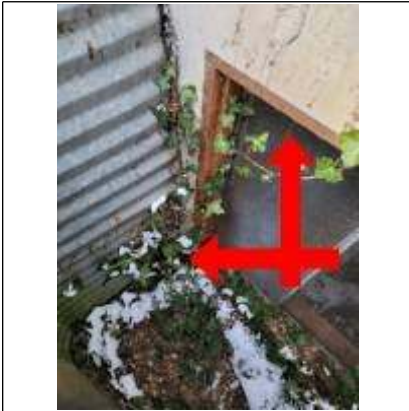
Window wells have vegetation growth. Recommend removal of all vegetation from the window wells

Vegetation growth in window well south side of home

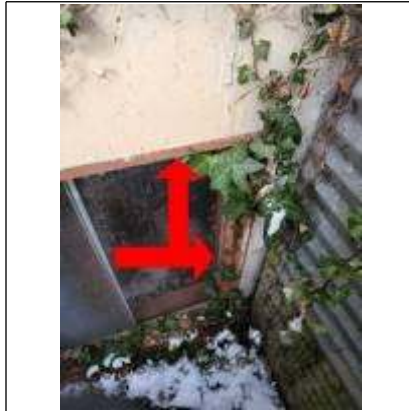
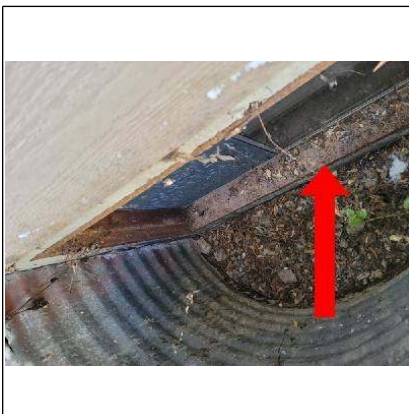
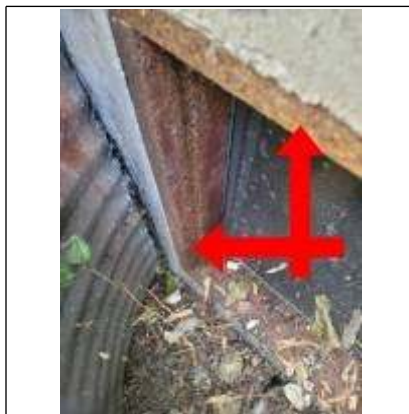
Exterior window well window frames are rusted. Recommend removal of all existing rust and reseal with exterior paint to prevent rust damage of the window frames

Rusted window well frame south side of basement

Rusted window well frame east side of basement

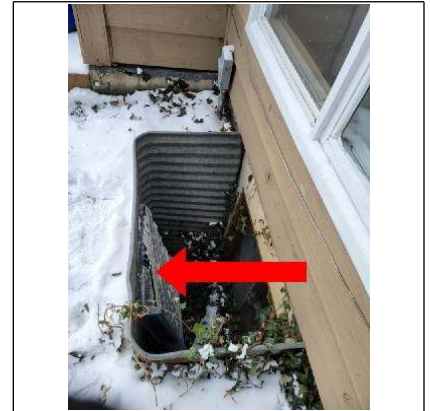
Improper installation of window wall cover

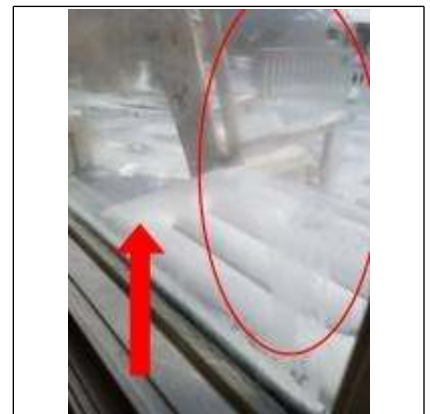
Exterior window of the south side of the home. Recommend repair or replacement of exterior window for best heating and cooling efficiency of the home

Evidence of failed thermal insulation seal of ground level window south side of home

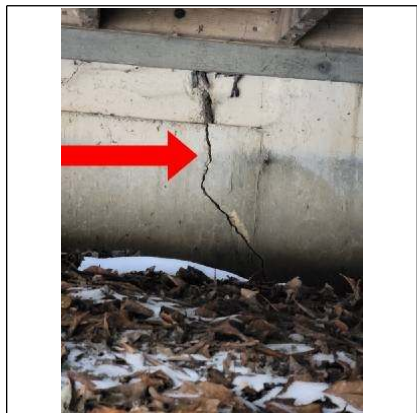
Vertical crack found on the exterior of the foundation stem wall on the south side of the home. Recommend qualified basement waterproofing contractor evaluate and repair as needed to prevent water intrusion into the crawl space / basement

Vertical crack of exterior concrete stem wall from the basement south side of home

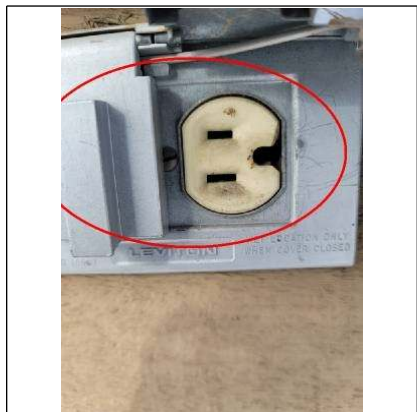
Exterior electrical receptacle on the south side of the home is not ground fault circuit interrupter protected. Recommend qualified electrical contractor install GFCI electrical receptacle for safe use

Non GFCI exterior electrical receptacle south side of home

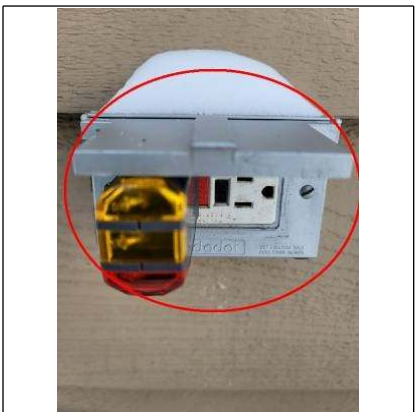
Exterior electrical GFCI receptacle on the east side of the home is inoperable. Recommend qualified electrical contractor evaluate and repair as needed for proper operation

Inoperable exterior electrical receptacle east side of home

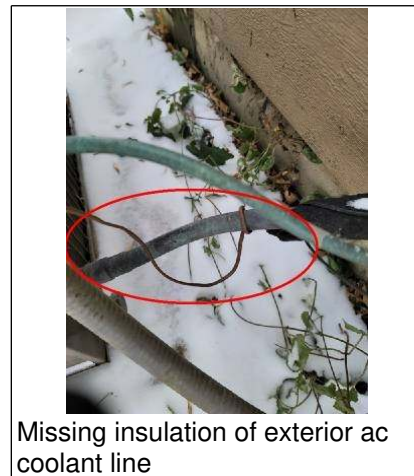
Missing insulation of exterior ac coolant line

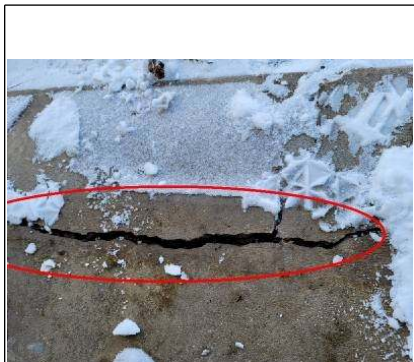
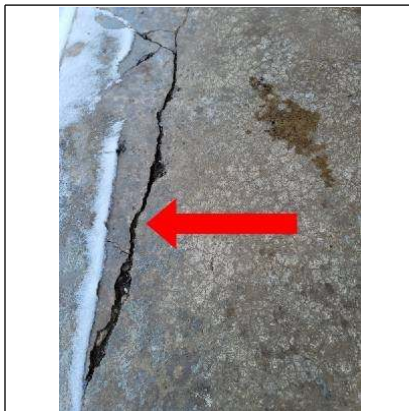
Concrete slab of garage floor has typical cracks along the footer seal and apron. Recommend sealing cracks to prevent water intrusion into the aggregate and further separation

Cracked concrete of garage floor

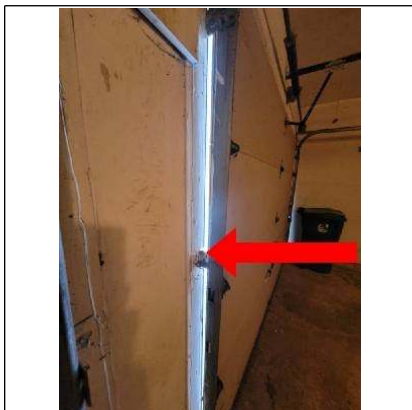
Garage doors have separation from the door jambs. Recommend installing weather stripping to prevent outside air and insect intrusion into the garage

Missing weather stripping of garage door

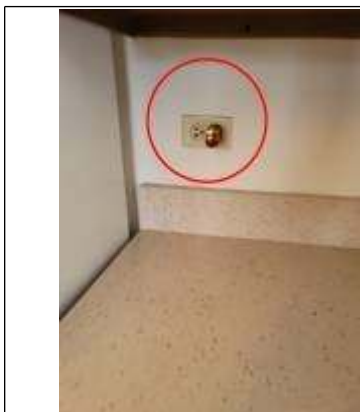
Some electrical receptacles above kitchen countertops are not ground fault circuit interrupter protected. Recommend qualified electrical contractor install GFCI protection for all receptacles above countertops for safe use

Non GFCI electrical receptacle above kitchen countertop

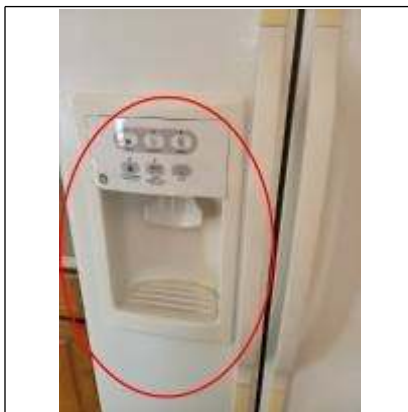
Ice and water dispenser of the refrigerator is inoperable. Recommend repair for proper operation

Inoperable ice and water dispenser of refrigerator

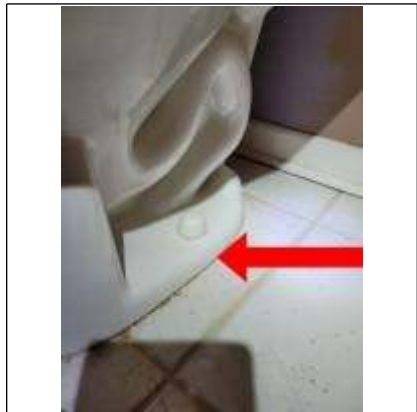
Second floor bathrooms have loose toilet bowls. Recommend qualified plumbing contractor replace seals and reinstall commodes with secure fit to prevent leakage into subflooring and lower living space

Loose toilet bowl second floor primary bathroom

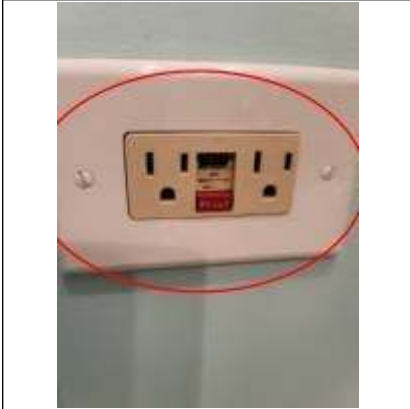
Electrical receptacle in the second floor hallway bathroom is inoperable. Recommend qualified electrical contractor repair or replace receptacle for proper operation

Inoperable electrical receptacle in second floor hallway bathroom

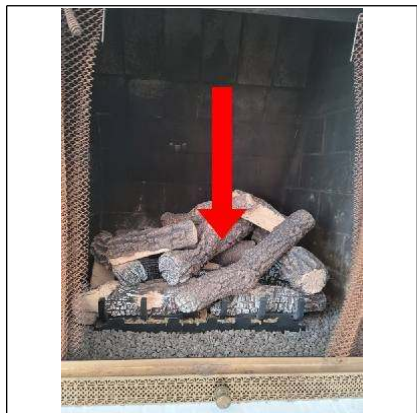
Gas fireplace appliance in the West living room is inoperable. Recommend restoring gas supply to the appliance and reevaluate her proper operation

Inoperable gas fireplace appliance

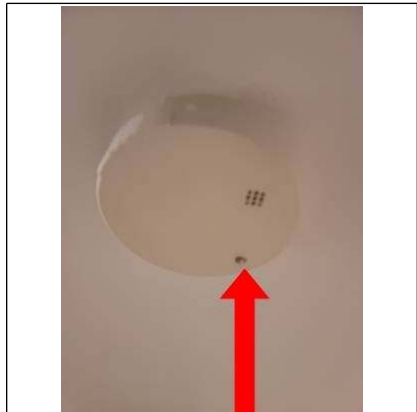
Home is not equipped with sufficient smoke and carbon monoxide detectors. Recommend installing smoke and carbon monoxide detectors on each level of home

Inoperable smoke detector in basement

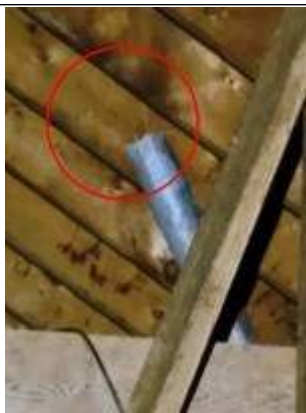
Master bathroom vent fan is exhausting into the attic. Recommend qualified building contractor extend vent pipe to the exterior of the roof to prevent moisture damage of the sheathing and rafter materials and hazardous fungal accumulation

Bathroom vent fan exhausting into the Attic

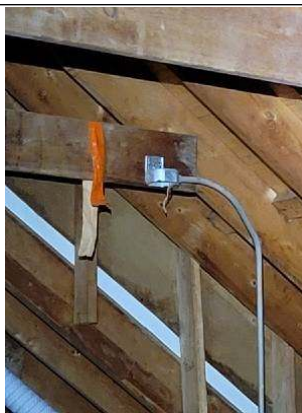
Electrical junction box in the Attic is missing protective cover plate. Recommend installing protective cover plate to prevent injury from contact with live electrical wires

Open electrical junction box in the Attic

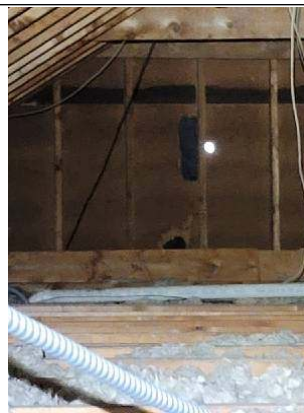
East exterior Wall of the Attic has an open hole in the sheathing and siding materials. Recommend repair to prevent water and wildlife intrusion into the Attic

Hole in exterior wall of east side of attic

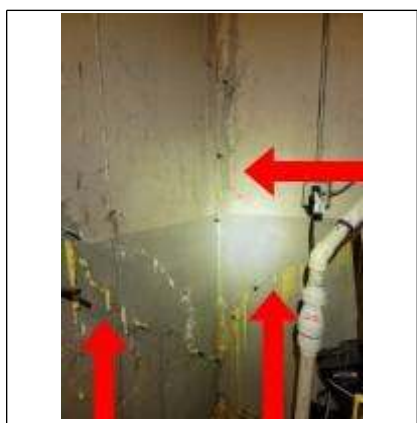
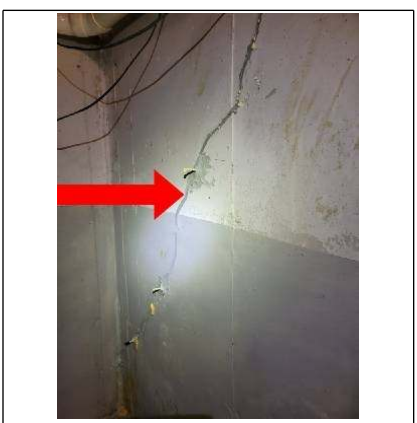
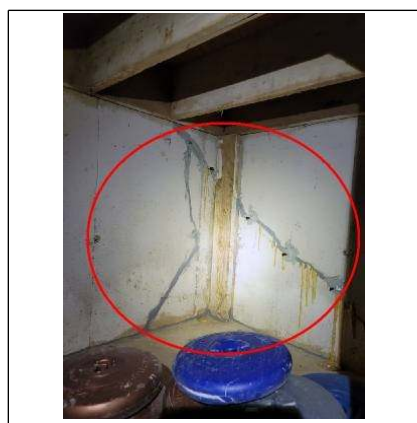
Patched vertical cracks found in the foundation stem walls on the north and east side of the basement. Recommend monitor repairs for activity and refer to basement waterproofing contractor for any further needed repairs to prevent water intrusion into the basement

Patched vertical cracks of foundation stem wall North east side of basement

Patch vertical crack in foundation stem wall north side of basement

Patched Vertical cracks in foundation stem wall north side of basement

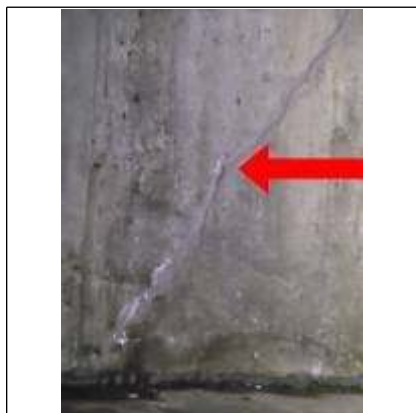
Vertical crack found in foundation stem Wall South side of crawl space. Recommend monitor for activity and refer to basement waterproofing contractor for any needed repairs to prevent water intrusion into the crawl space

Vertical crack of foundation stem wall South side of crawlspace

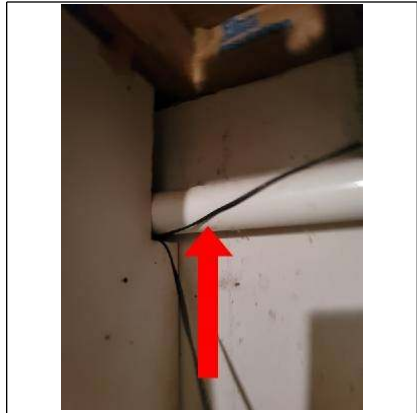
Horizontal drain pipe to the main stack in the basement is emitting a knocking sound. Recommend further evaluation by license plumbing contractor and repair as needed

Knocking sound from horizontal drain pipe to main stack

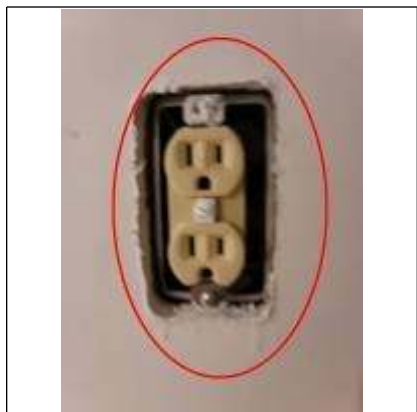
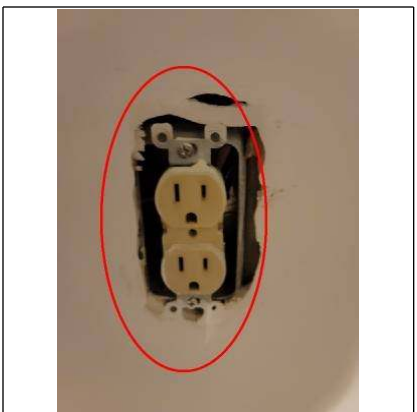
Electrical junction boxes in the basement are missing protective cover plates. Recommend installing missing protective cover plates to prevent injury from contact with live electrical wires

Missing protective cover plate of electrical junction box in basement

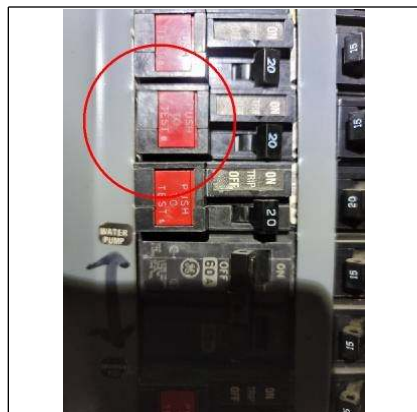
Arc-fault breaker test button in the service panel is inoperable. Recommend repair or replacement for proper operation

Inoperable test button of arc fault breaker in service panel
